# COASTAL PROCESSES AND MARINA SILTATION

ANONYME ISLAND, SEYCHELLES

## PROJECT INFORMATION:

## PROJECT DESCRIPTION:

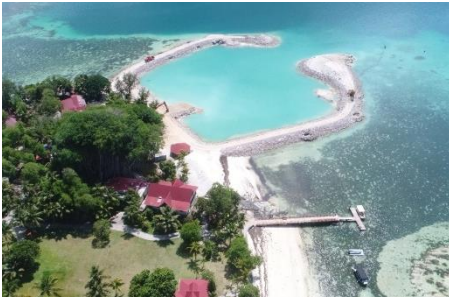
**(top L to R)** The finished marina and under construction in March 2018; modelled residual current speeds between September and December 2018 – the period of time when the siltation supposedly occurred. Note the lack of current vectors entering the marina. **(bottom)** Deploying a current meter; a proposed dewatering tube for separating dredged sludge from the water; proposed staging areas for the dewatering operation highlighted in red.

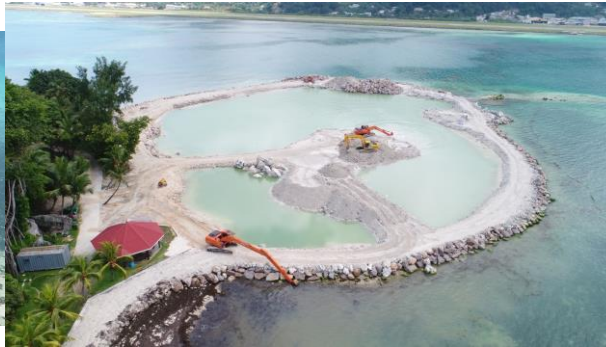
Each of these possibilities were considered in the context of the hydrodynamic forcing around the island. The results suggest that hydrodynamically forced infilling is unlikely, if not impossible due to fact that 1) the hydrodynamics do not support the transport of material into the marina and 2) there is no possible source for the requisite volume (10,000 m<sup>3</sup>) of silt to have been transported into the marina since the waters around anonyme are clear and silt free.
