# COASTAL PROCESSES AND MARINA SILTATION

ANONYME ISLAND, SEYCHELLES

## PROJECT INFORMATION:

## PROJECT DESCRIPTION:

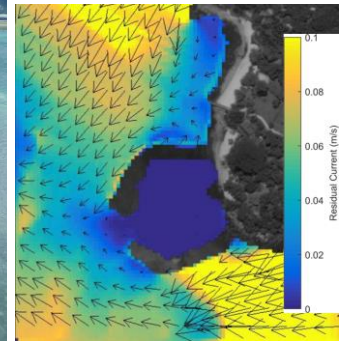
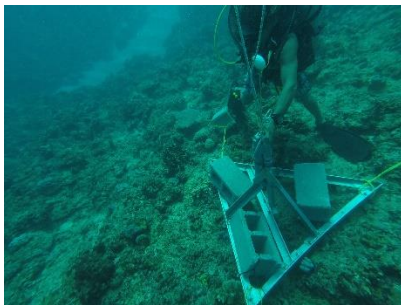
**(top L to R)** The finished marina and under construction in March 2018; modelled residual current speeds between September and December 2018 – the period of time when the siltation supposedly occurred. Note the lack of current vectors entering the marina. **(bottom)** Deploying a current meter; a proposed dewatering tube for separating dredged sludge from the water; proposed staging areas for the dewatering operation highlighted in red.

Each of these possibilities were considered in the context of the hydrodynamic forcing around the island. The results suggest that hydrodynamically forced infilling is unlikely, if not impossible due to fact that 1) the hydrodynamics do not support the transport of material into the marina and 2) there is no possible source for the requisite volume (10,000 m<sup>3</sup>) of silt to have been transported into the marina since the waters around anonyme are clear and silt free.
