MANAGEMENT OF COASTAL INUNDATION AND EROSION

CLUB MED RESORT, ALBION, MAURITIUS

Location: Albion, Mauritius

Project Date: January – October 2024

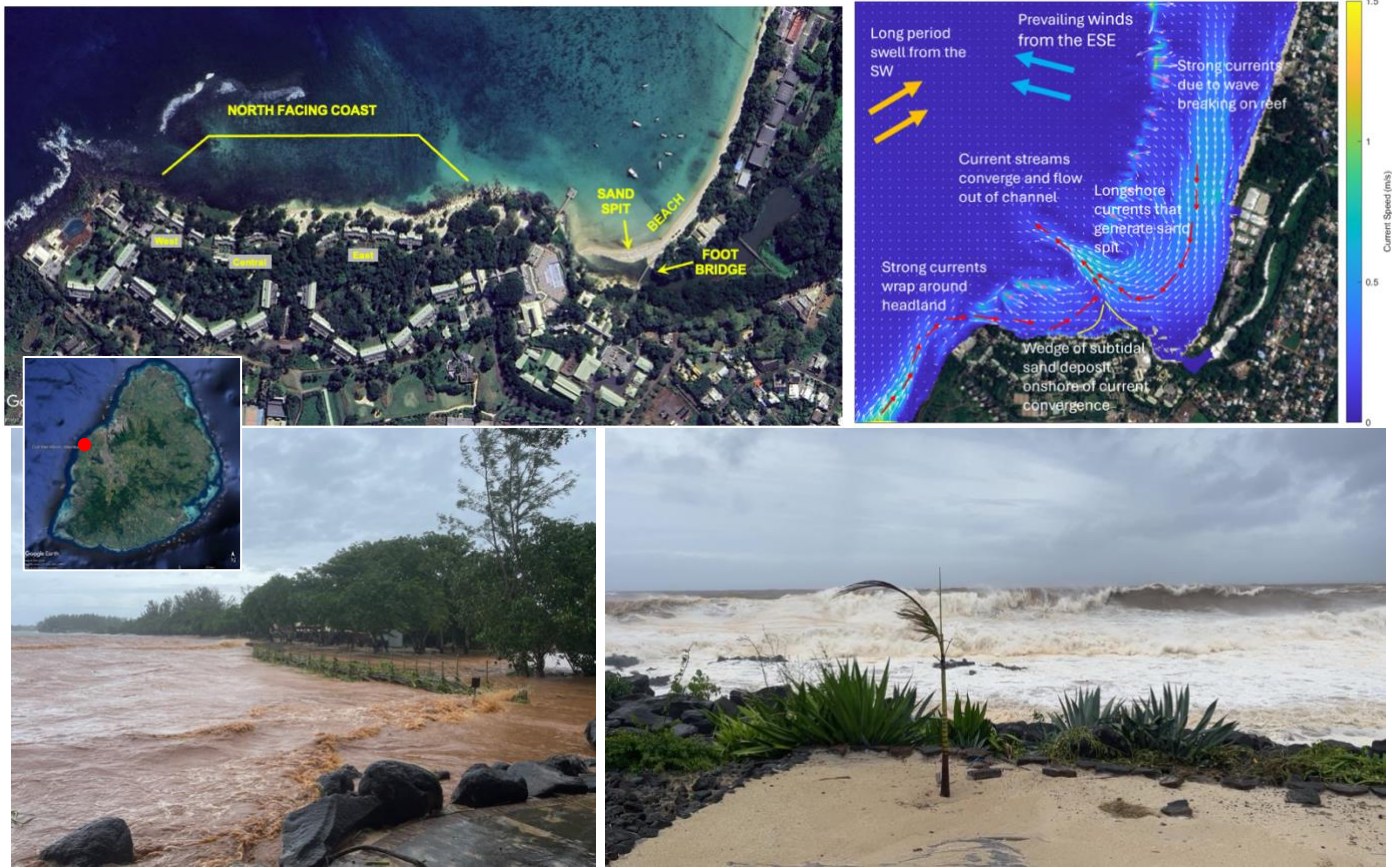
(inset) red dot shows the location of Albion (top left) the layout of the Club Med Resort (top right) numerical modelling results showing the coastal processes (bottom left and right) flooding and high waves at Albion during Cyclone Belal.

ORCAS conducted a coastal processes assessment for the Club Med Albion Resort on the west coast of Mauritius. The resort wishes to implement remedial works for a severely eroded shoreface on the north facing coastline of the embayment. Our assessment included a detailed site visit and hydrodynamic modelling of typical and extreme wave and water level conditions.

One key finding of our study was that sea levels have risen dramatically in Mauritius in the past 25 years with an unprecedented ~20 cm rise in average water level in just the past two years. It is this rise in water level in conjunction with the unfortunate confluence of strong waves and high astronomical tides that has led to the erosion problems being experienced at the resort. For the erosion along the north facing shoreline, we recommend the construction of a backstop sea wall in front of the villas. This sea wall would be constructed from pre-cast concrete sections set in place and tied back to the existing ground. On the landward side of the sea wall, an architecturally appropriate walking and access path should be developed. On the shoreward side of the wall would be a 1:1 sloped rock revetment built from 0.75 to 1.0 m diameter rocks with the larger toe rocks founded on bedrock. The toe of the revetment would sit above the high tide water line and as such, this wall will only come in to contact with ocean waves during storm conditions.
